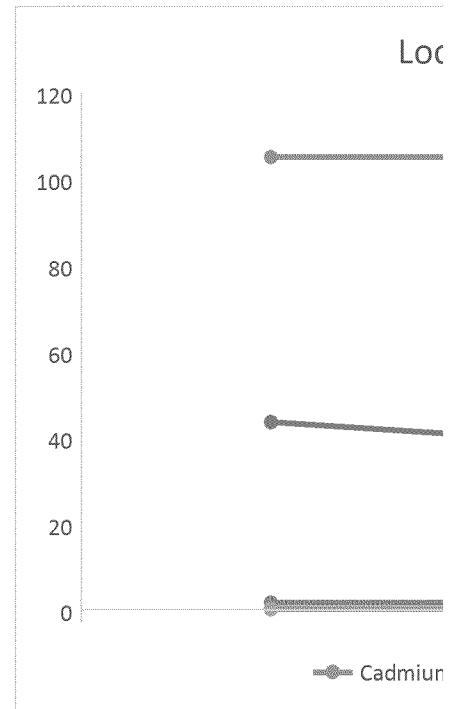
Location: 32nd Street Bridge

ocation ID	Date Sampled	Cadmium	Copper	Lead	Manganese	Zinc
32nd St Br	8/5/2015	0.178	1.7	0.24	105	43.5
32nd St Br	8/6/2015	0.16	1.56		105	37.8
32nd St Br	8/6/2015	0.19	1.62	0.115	97.8	49.1

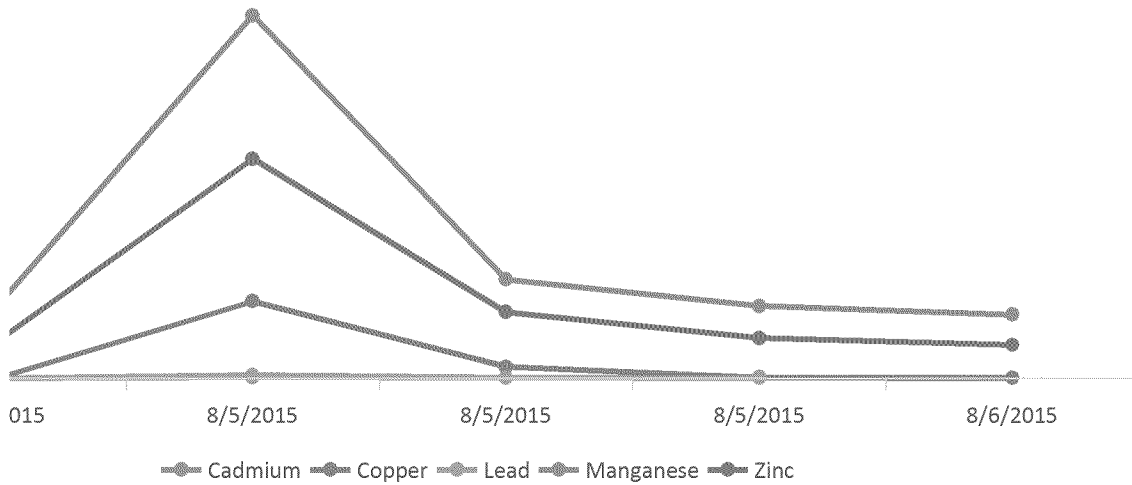
Location: A72

Location ID	De Sampled	Cadmium	Copper	Lead	Manganese	Zinc
A72	8/5/2015	1.81	9.27	0.225	1370	699
A72	8/5/2015	15.2	1410	50.7	6650	4020
A72	8/5/2015	4.29	205	3.12	1810	1210
A72	8/5/2015	2.59	11.4	0.118	1320	733
A72	8/6/2015	2.11	7.63		1160	609
